**SITE INVESTIGATION
PHOTOGRAPH ALBUM
SITE 10 - ORIGINAL BASE LANDFILL**

**MARINE CORPS BASE, CAMP LEJEUNE
NORTH CAROLINA**

CONTRACT TASK ORDER 0369

**BAKER ENVIRONMENTAL, INC.
*Coraopolis, Pennsylvania***

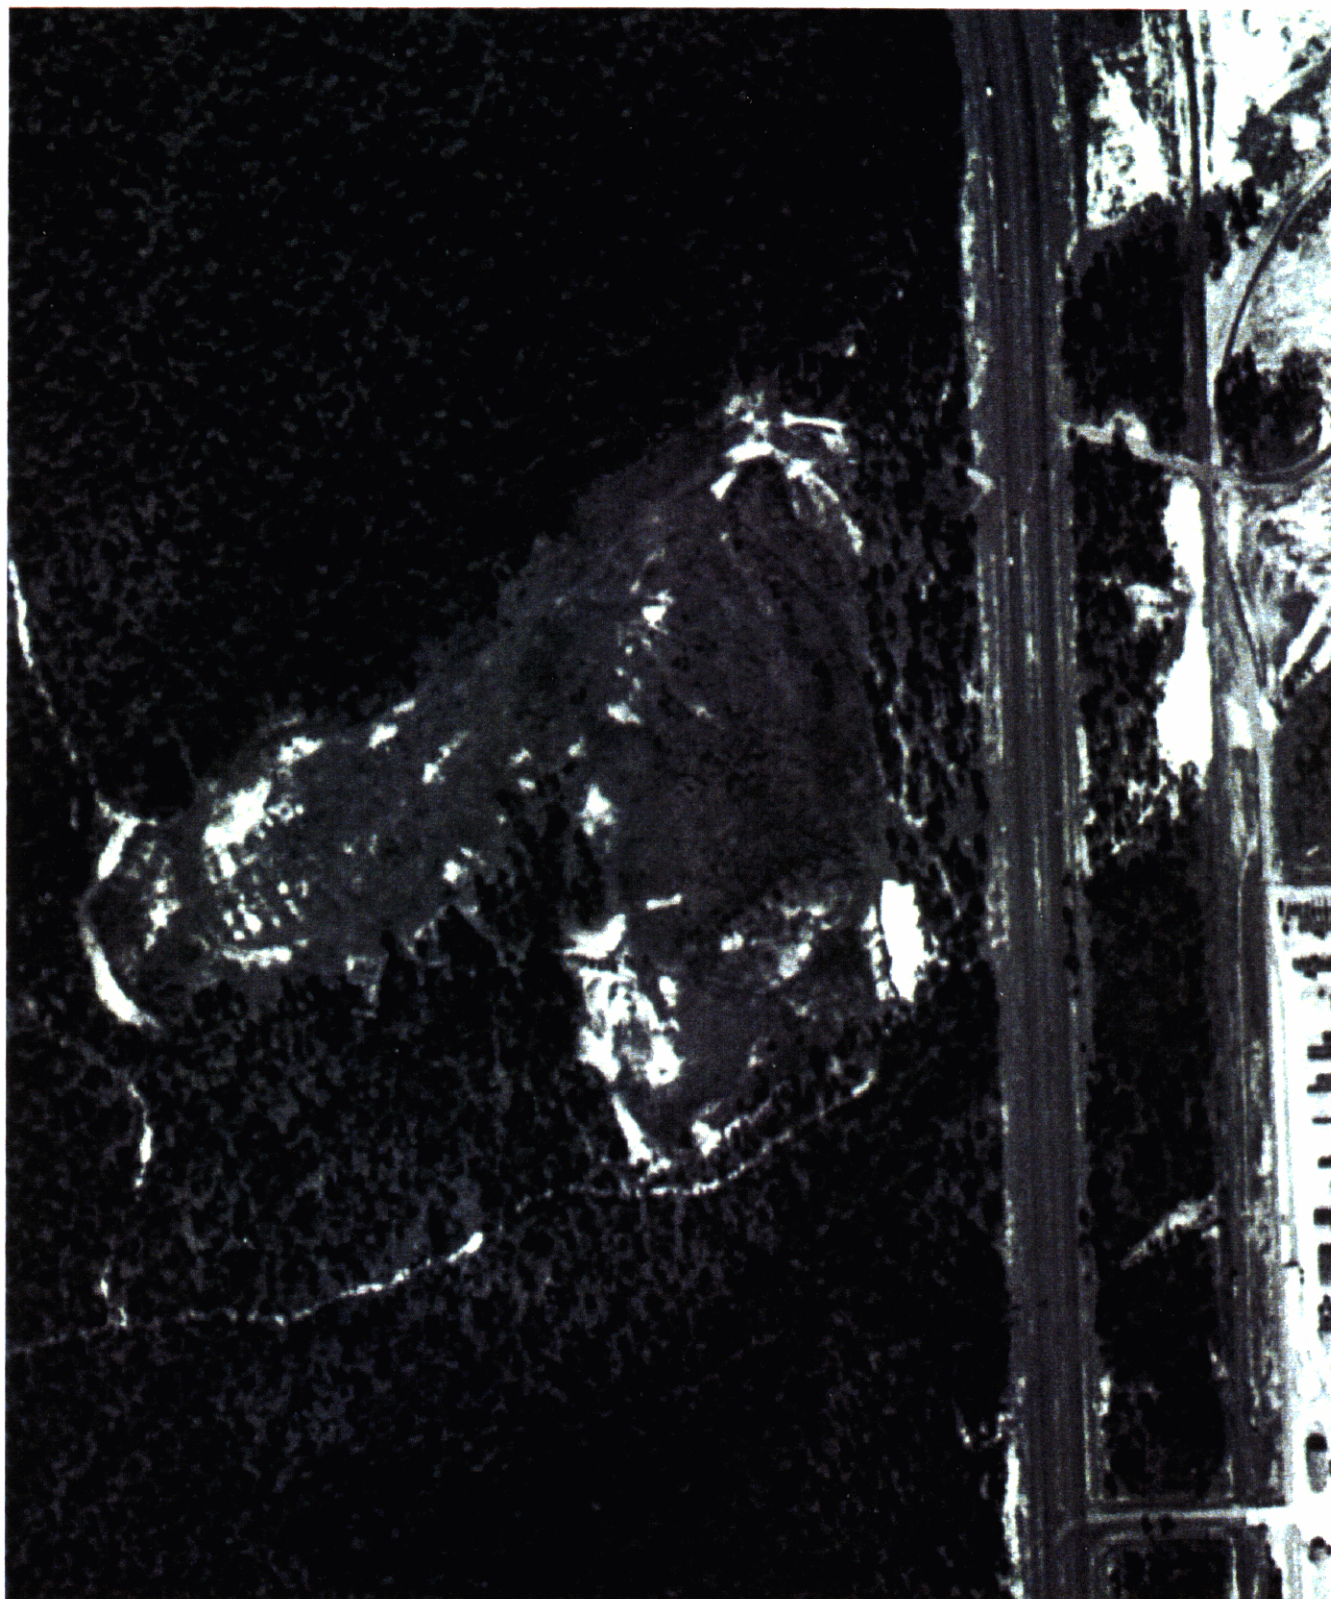
SITE 10. 1949. 1

AERIAL PHOTOGRAPH OF SITE 10 TAKEN OCTOBER 21, 1949.
CLEARLY DEPICTS THE KIDNEY SHAPE OF THE SITE. MOST
OF THE TREES ON THE SITE HAD BEEN CLEARED.

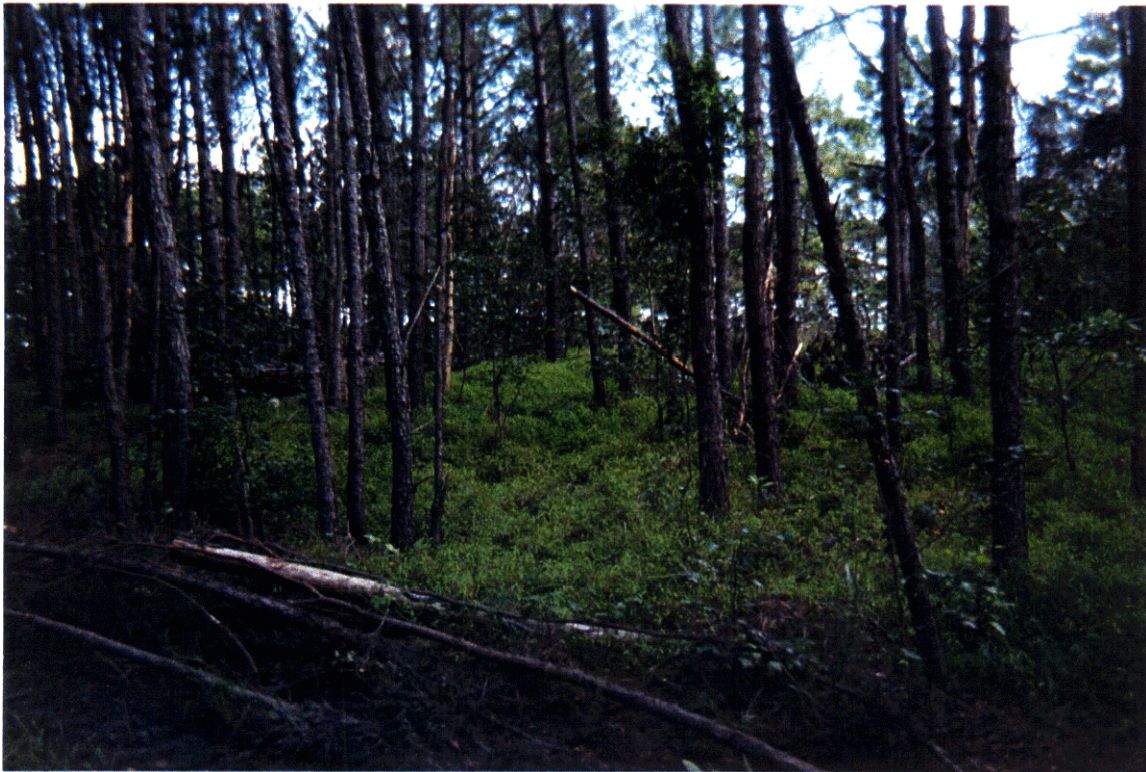
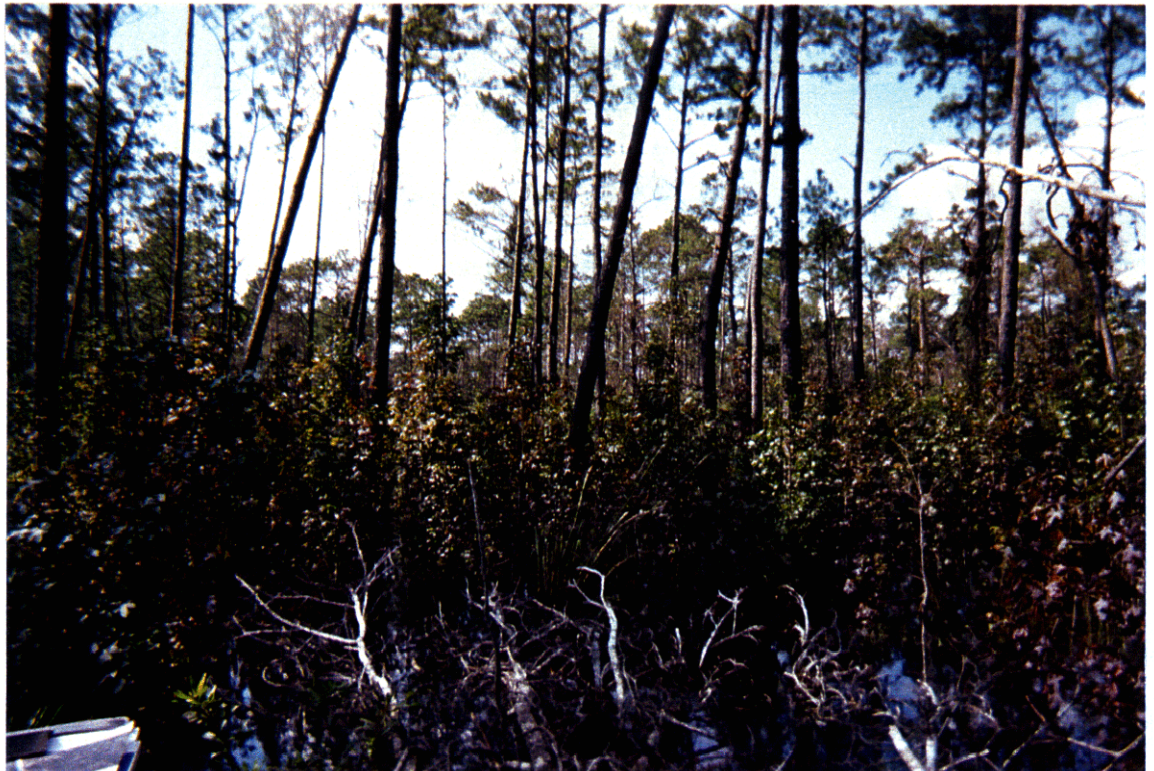
These photographs taken in 1986 illustrate the young age of the trees on Site 10 (30-40 years) and the thick underbrush which is present throughout much of the area. This type of habitat is typical of an area which is reestablishing itself after a disturbance.

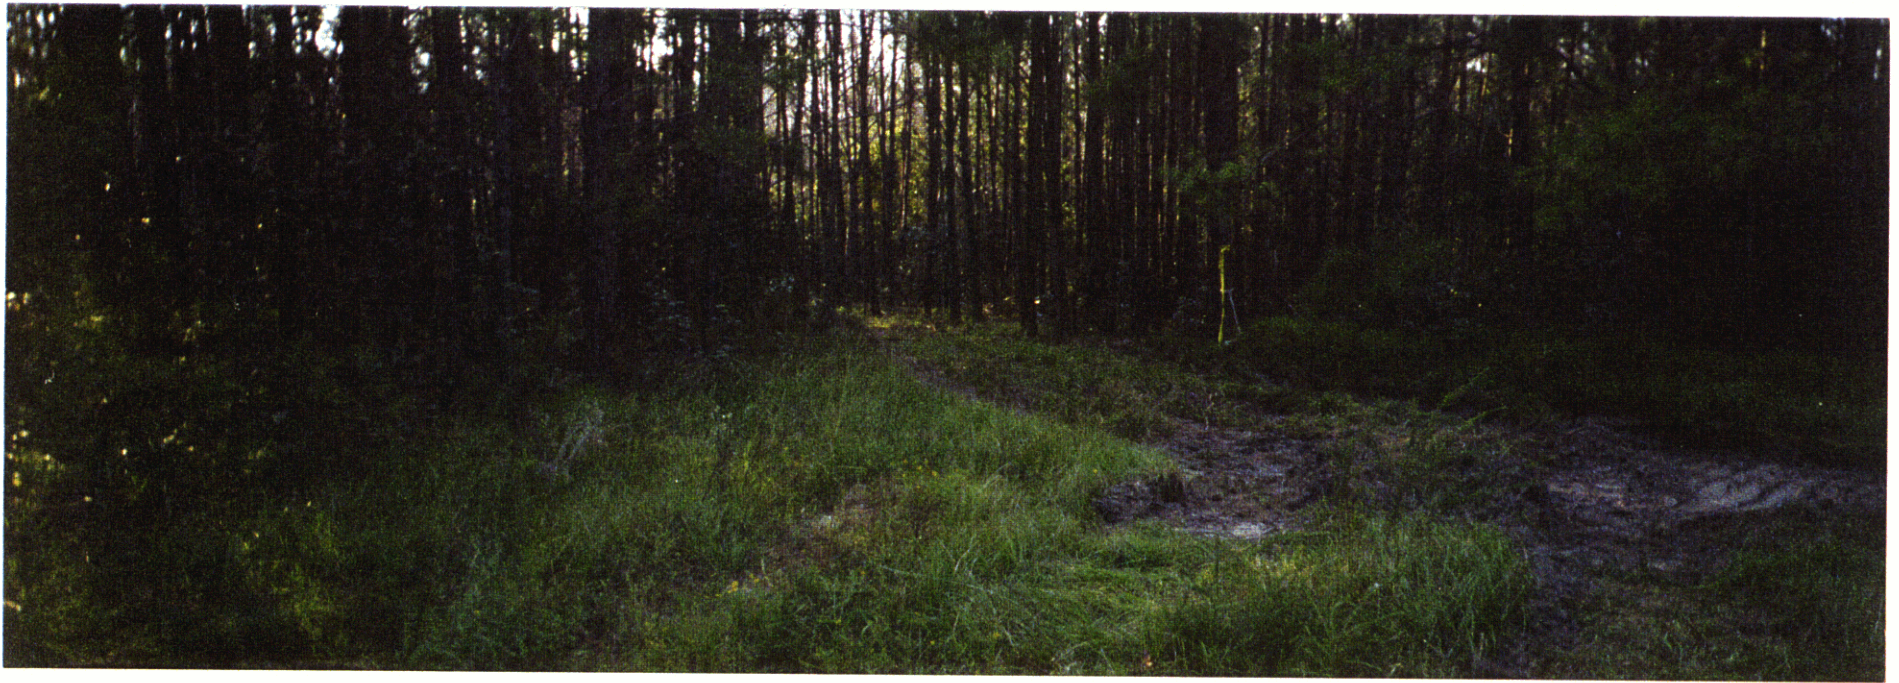
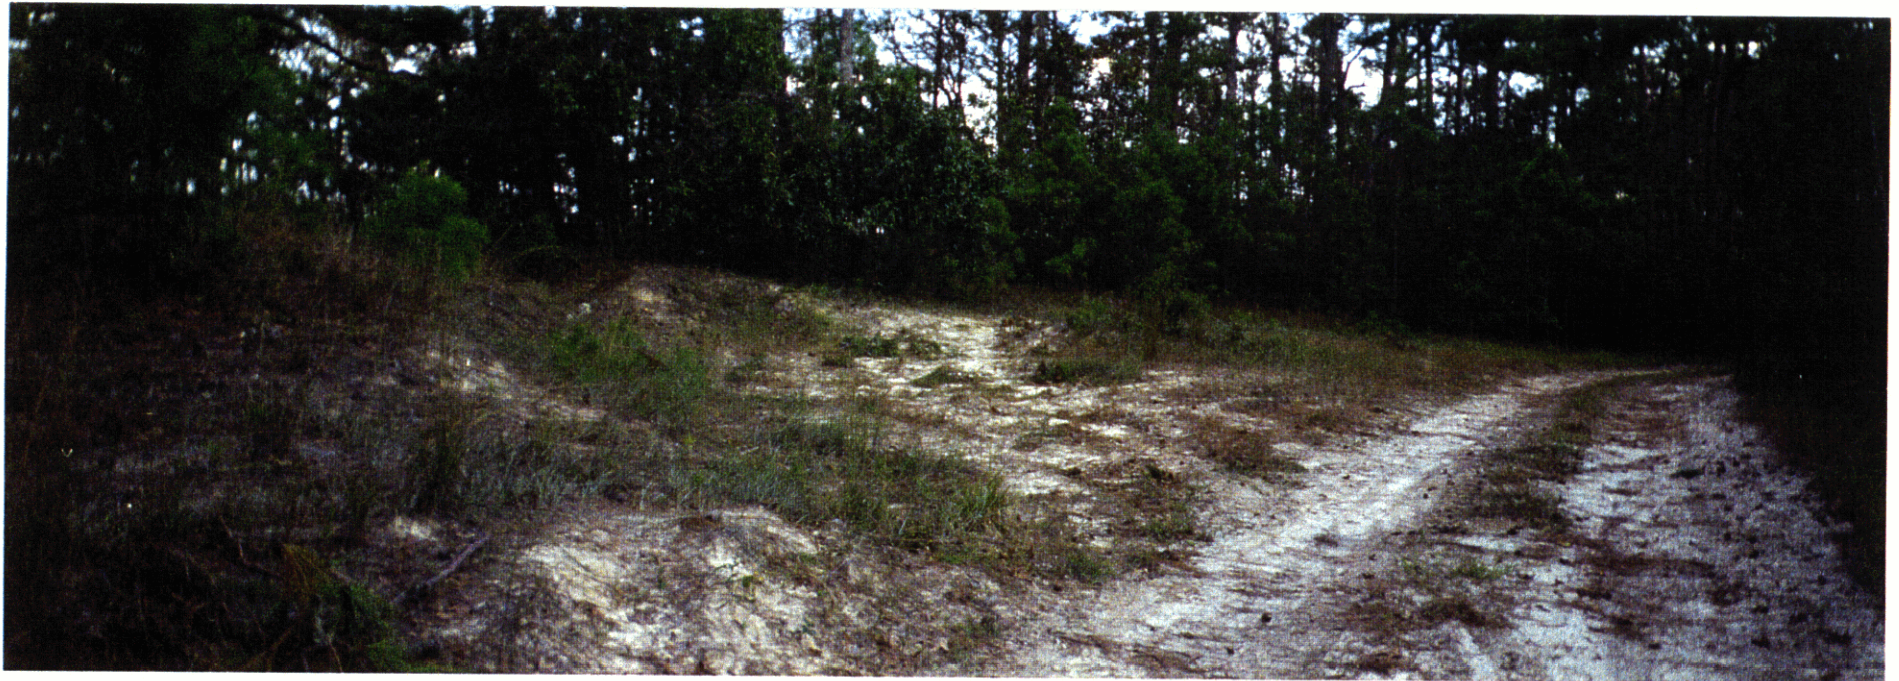
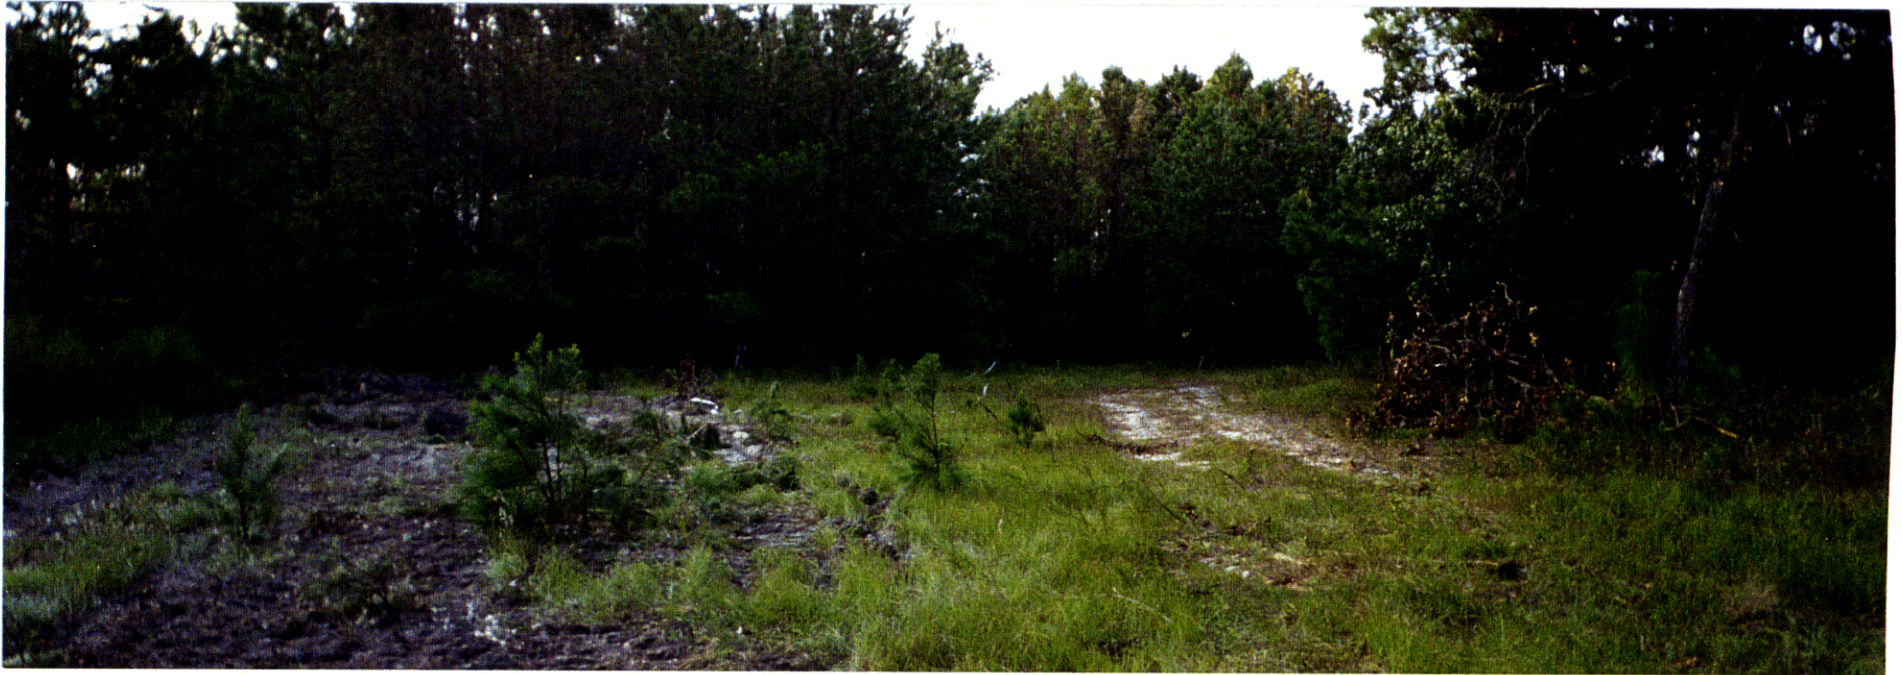
Clearings are still visible throughout much of the site. The young age of the trees and underbrush is also illustrated. Although the access roads are becoming overgrown, they are still obvious throughout the site. These access roads, first established for access to the landfill, are still being used for military training maneuvers.

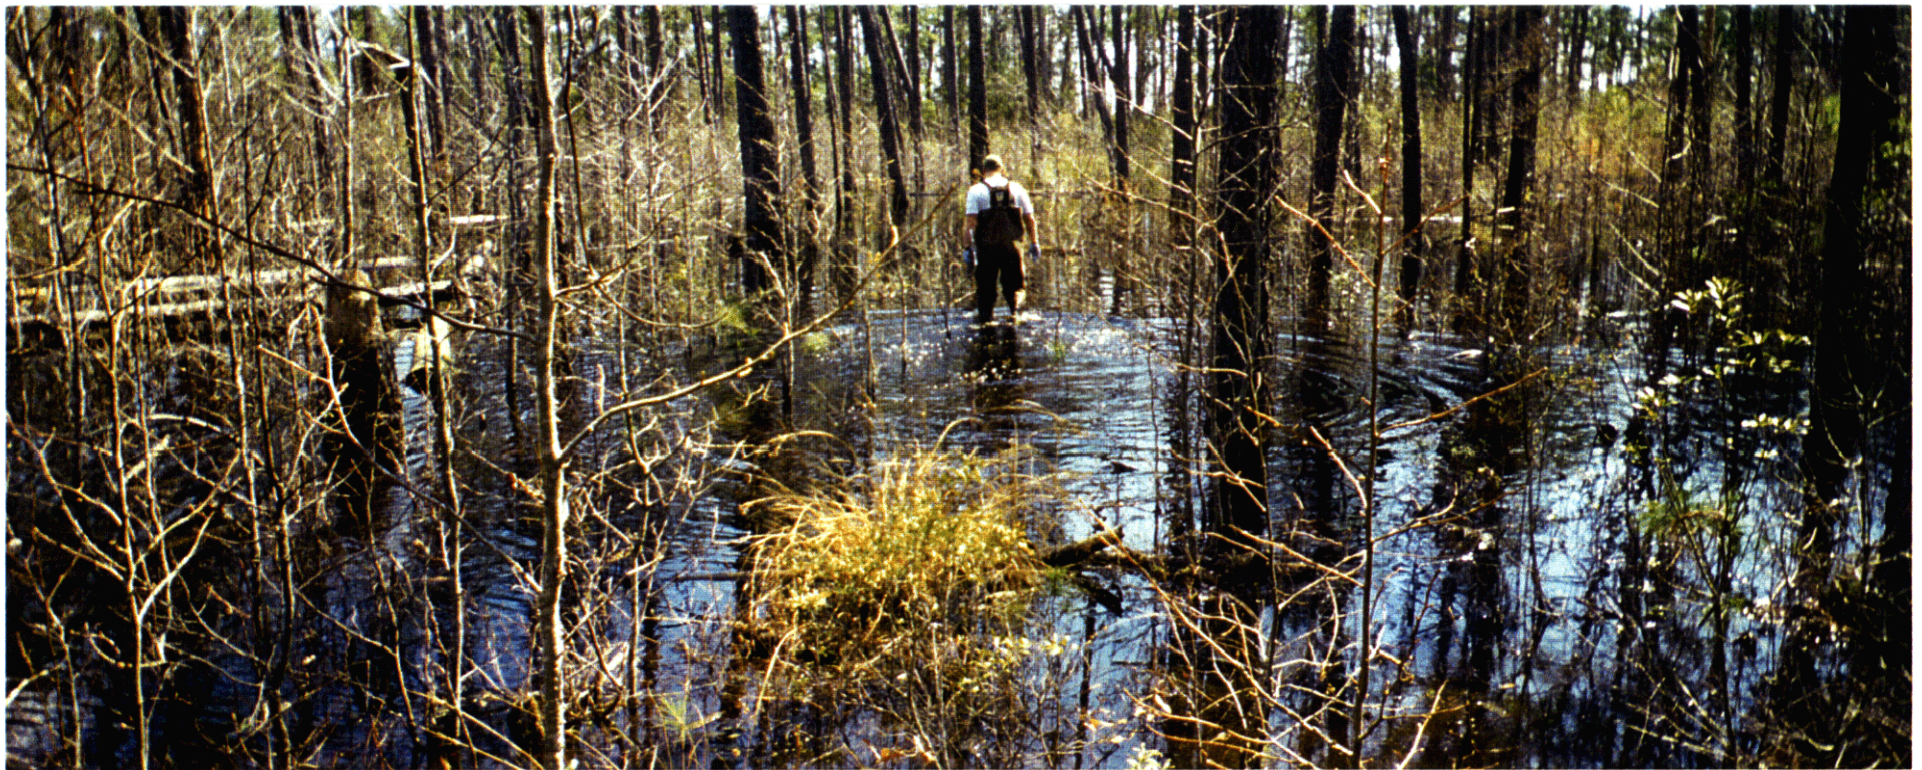
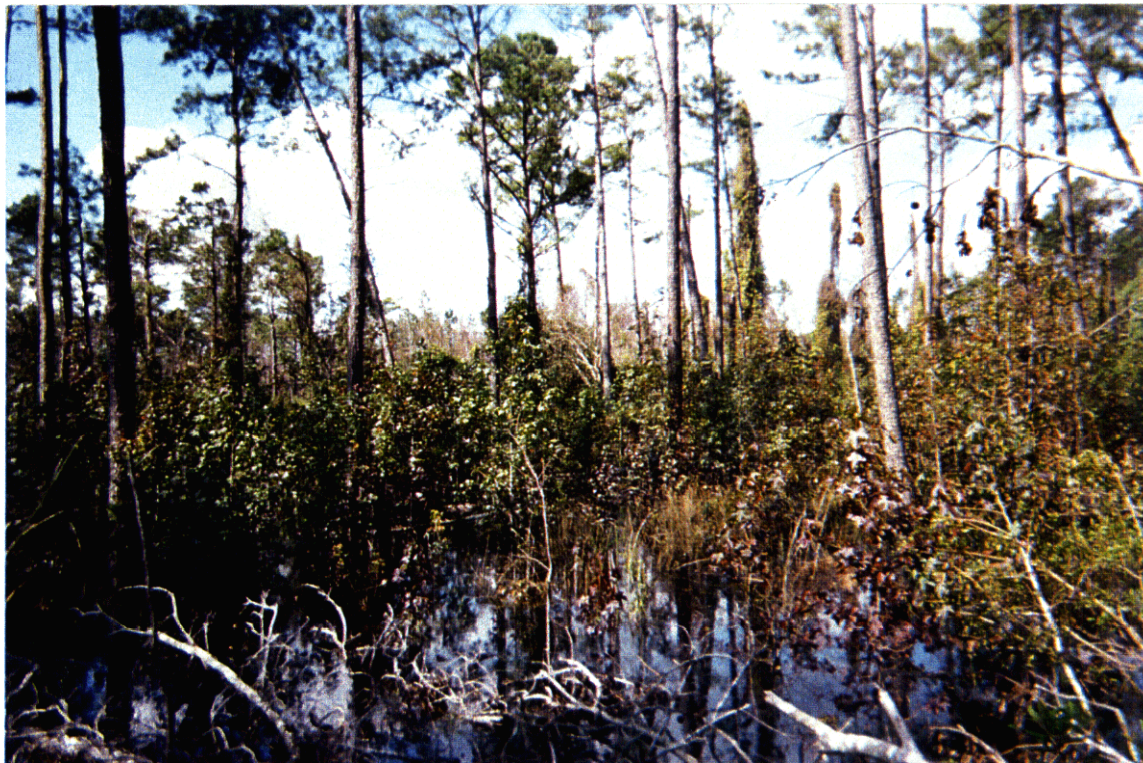
Although unexpected, two relatively large shallow ponded areas exist on Site 10. They are located in topographically low areas during the rainy seasons. The terrestrial vegetation in the ponded areas and the lack of aquatic life indicate that the ponds are most likely seasonal in nature.

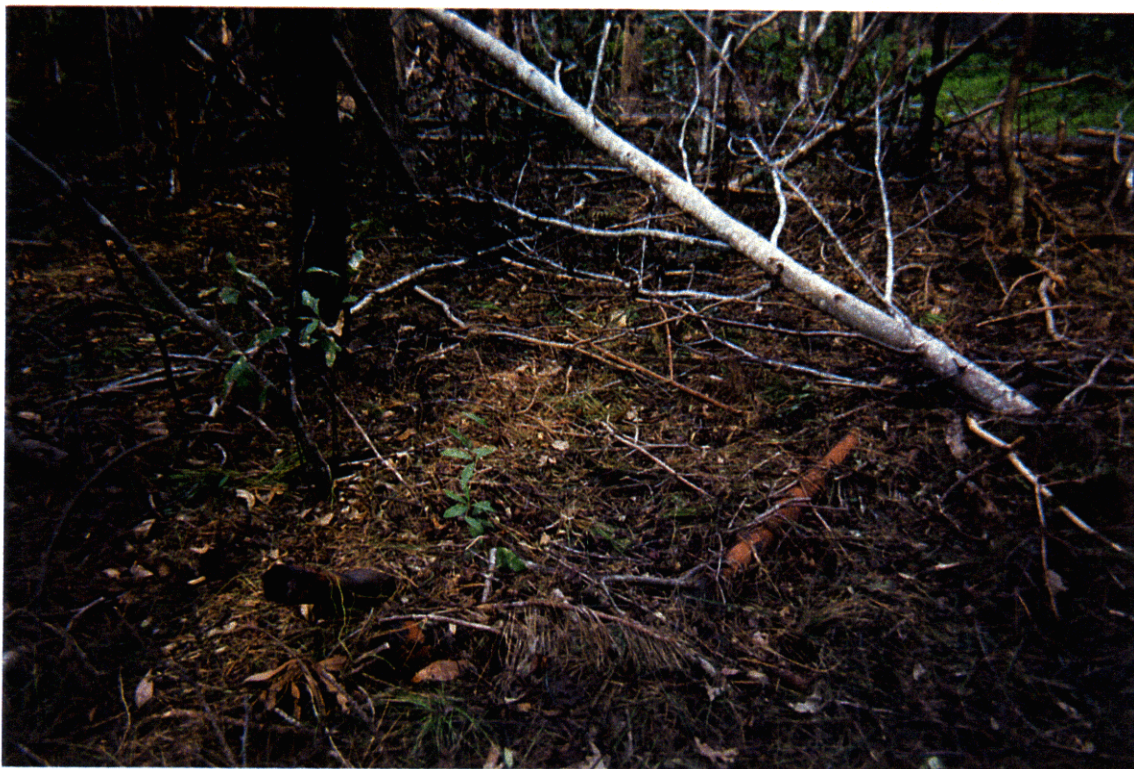
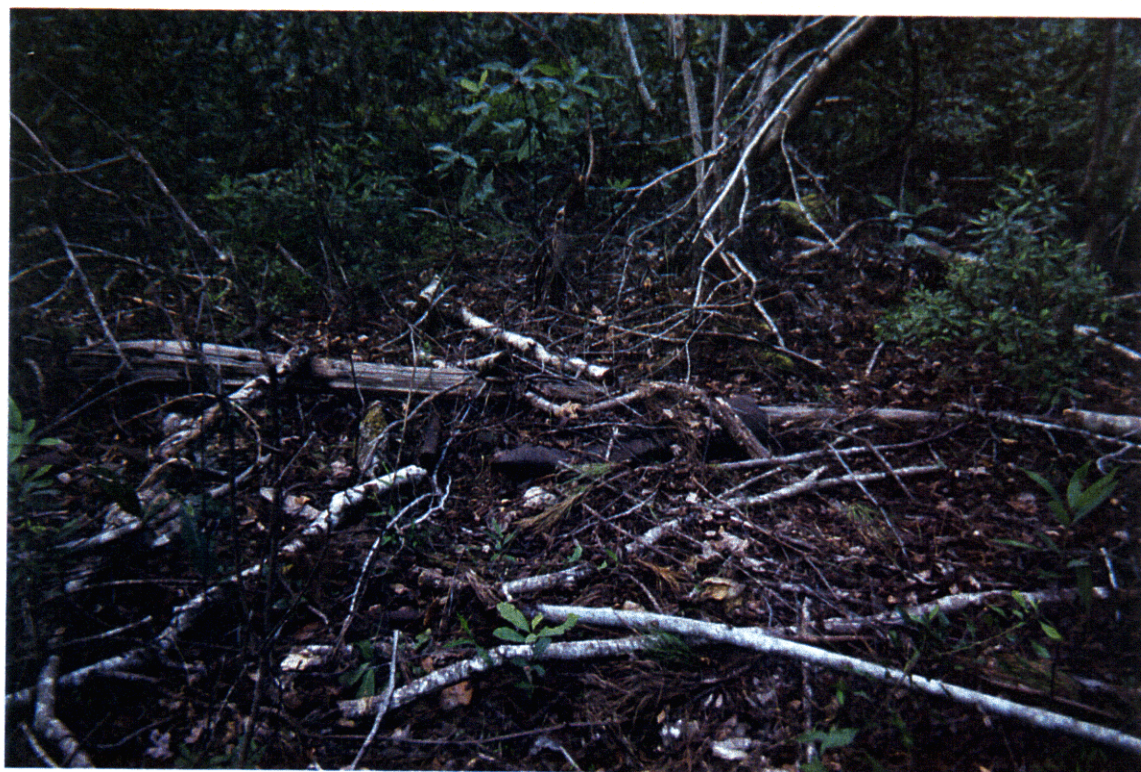
An Initial Assessment Study indicated that the site was used as a disposal site for construction debris and as a burn site. These pictures, taken on a site visit in September 1996, confirm the presence of concrete, scrap metal, and metal piping within the boundaries of the site.

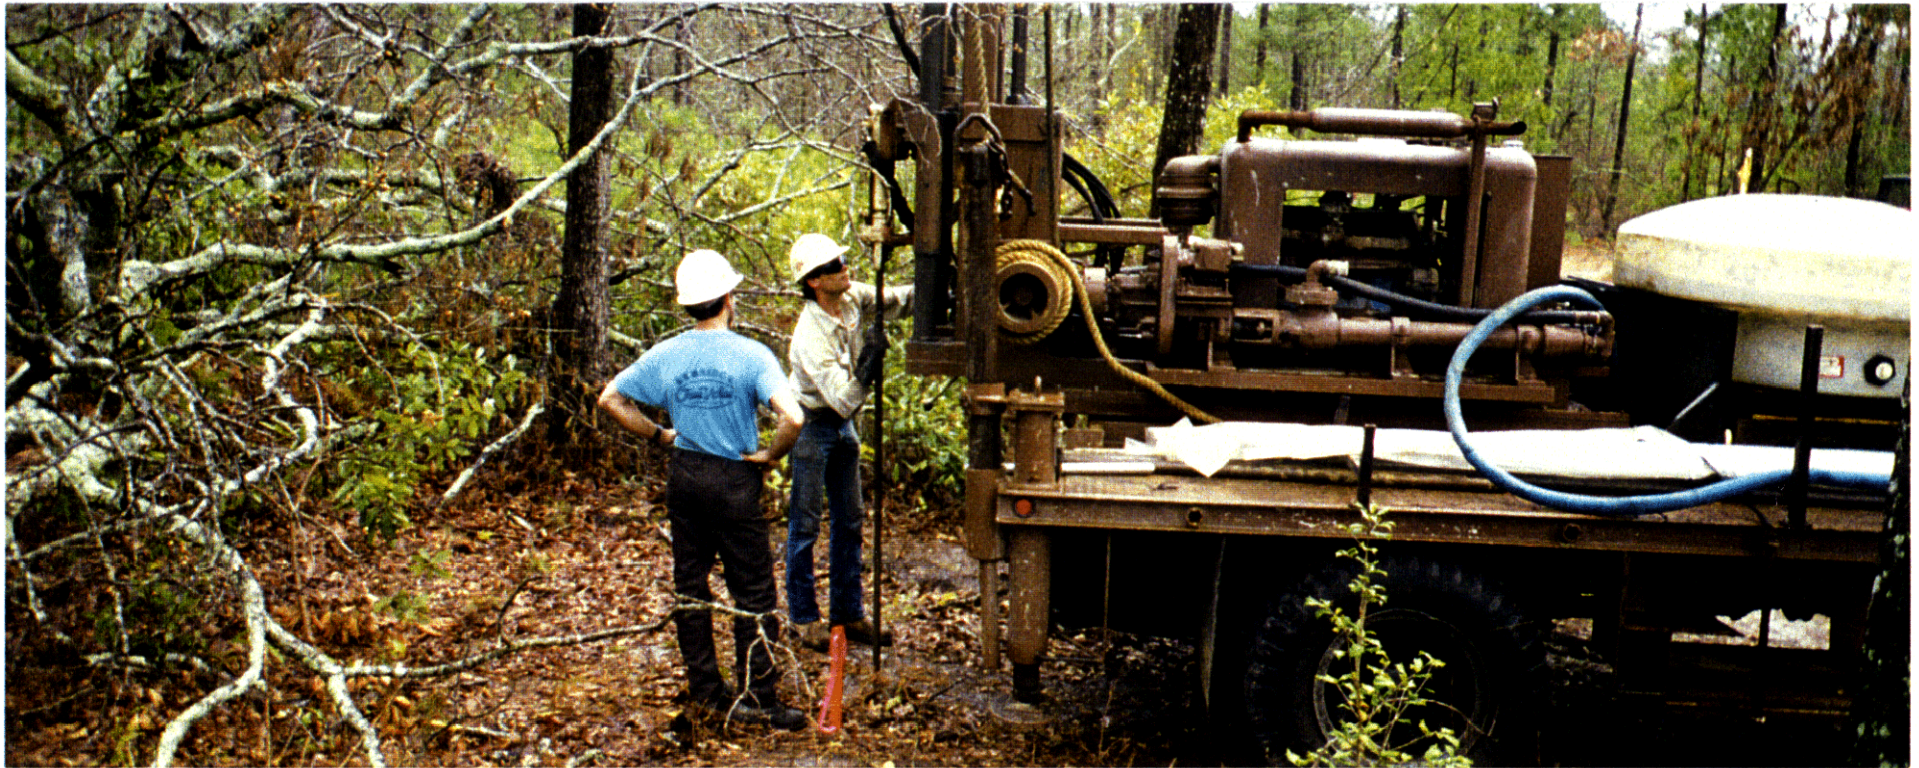
Site 10.1998.11

Parratt Wolfe, Inc. conducted the drilling activities at Site 10 using a truck-mounted geoprobe rig. Twenty-five soil borings were advanced for the purpose of sample collection, geological identification and description, and temporary monitoring well installation. Soil samples were obtained via a direct push soil sampler. Surface soil samples were collected from 0-12 inches below ground surface (bgs) after the first few inches of top soil and matted roots were removed. A single vadosezone subsurface soil sample was collected from directly above the water table in each boring. Sixteen soil borings were advanced for soil classification and sample collection purposes only and were terminated at the water table. The remaining nine soil borings were completed as temporary monitoring wells extending 5-10 feet below the water table.

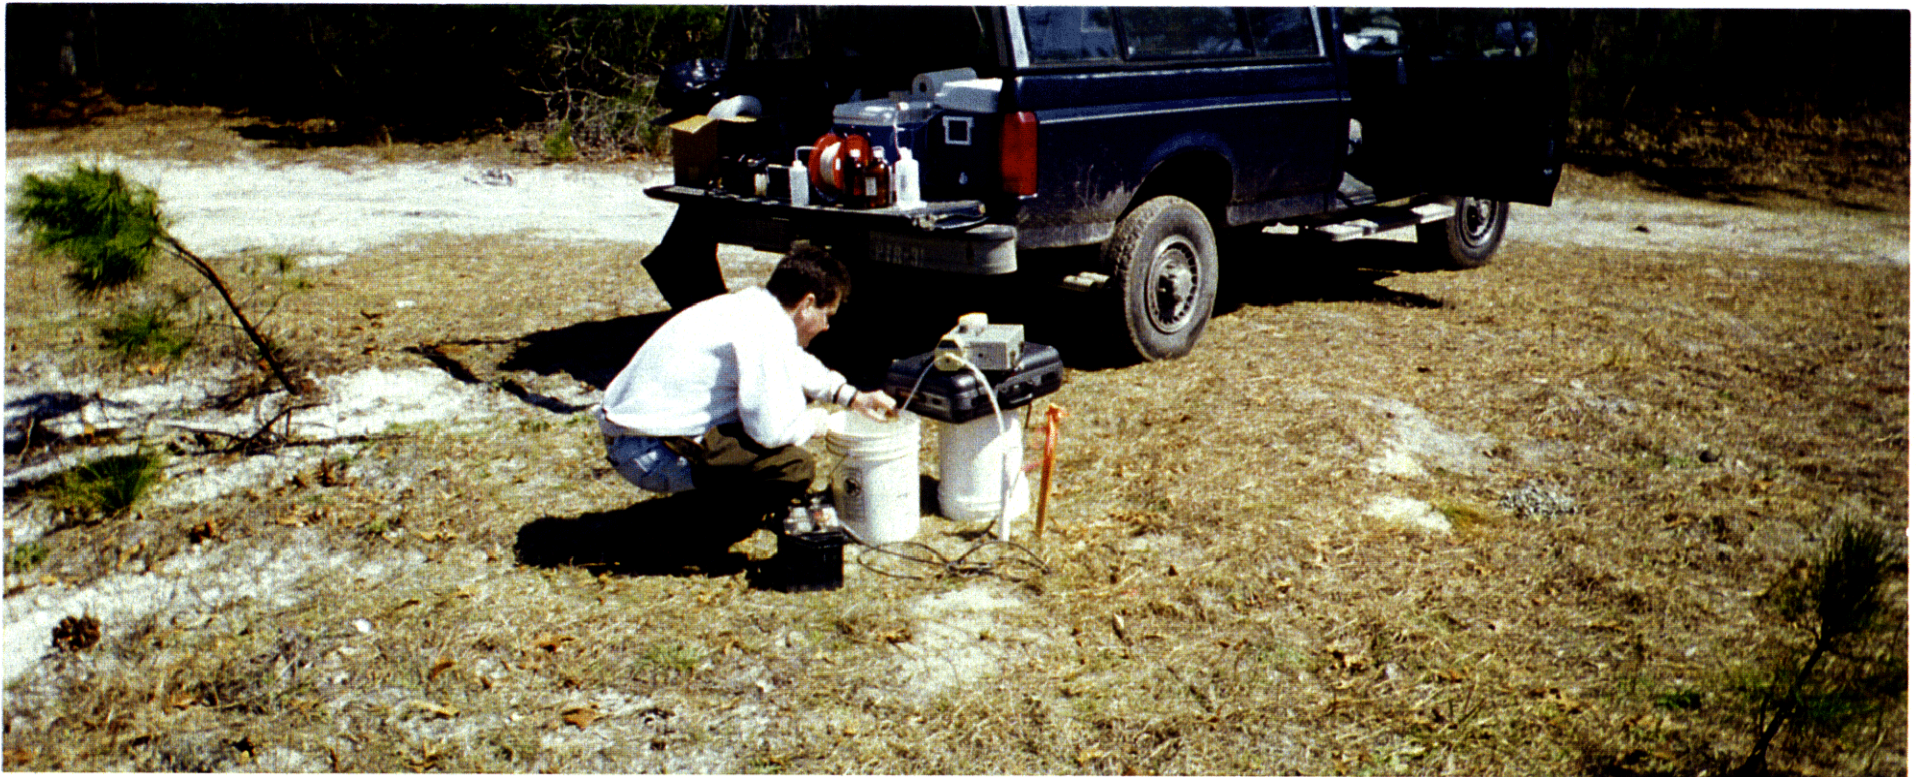
Site 10.1998.12

A peristaltic pump and teflon tubing were used to collect the groundwater samples from the surficial aquifer under Site 10. Prior to sampling, the wells were purged a minimum of 3-5 well volumes using low-flow techniques until the groundwater had stabilized. Temperature, conductivity, turbidity, and pH were collected after each well volume was removed to determine stabilization.

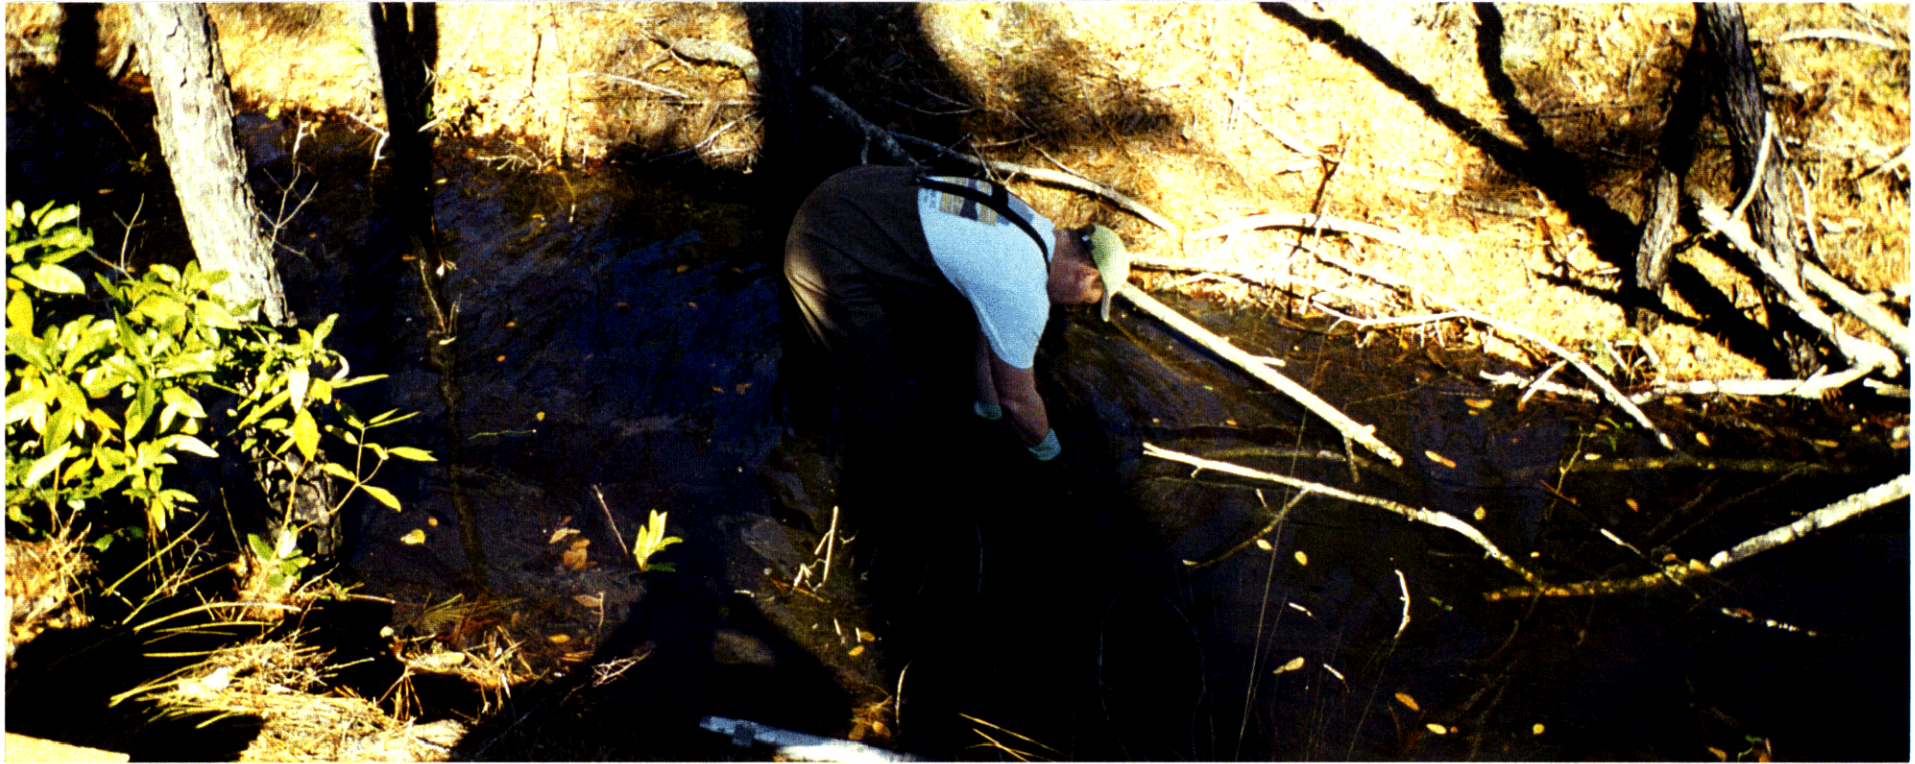
Site 10.1998.13

Six surface water samples were obtained from the two ponded areas and a small stream leading away from the northern-most pond. They were collected by dipping an unreserved sample jar into the water at the approximate mid-verticle point then transferring the sample to the appropriate sample containers. Since the water bodies were nearly stagnant, samples were collected with care to minimize sediment disturbance and suspension.

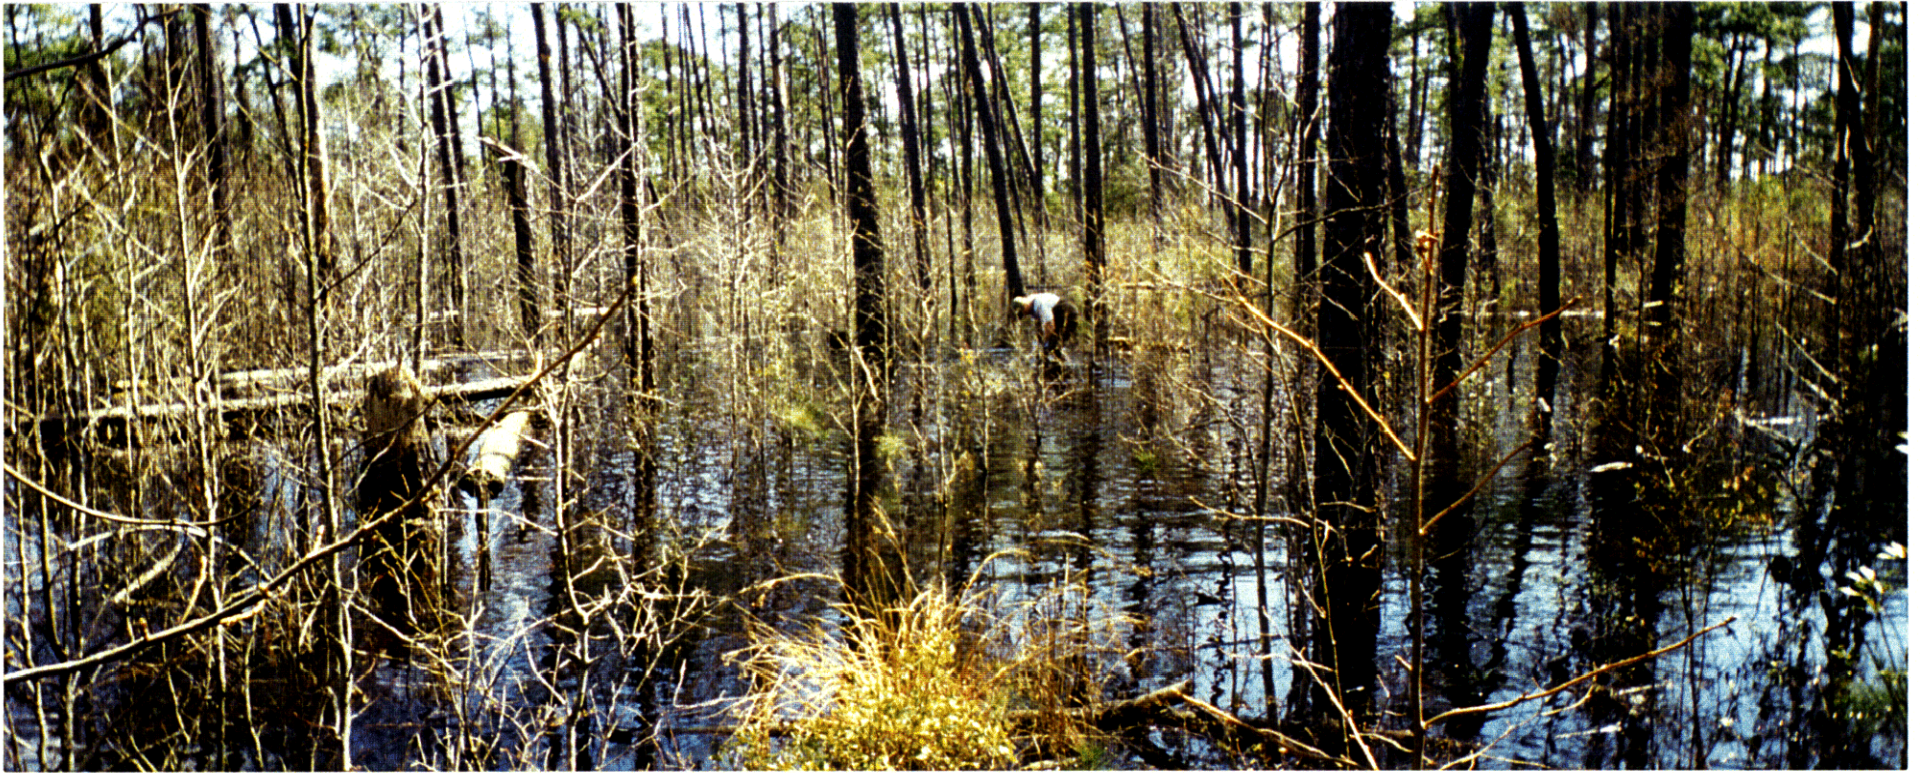
Site 10.1998.14

Sediment samples were obtained from the six surface water sites in the two ponded areas and stream. They were collected after the surface water samples to minimize sediment disturbance and suspension. Samples were collected from 0-6 inches using a decontaminated stainless steel sediment corer fitted with a new disposable plastic liner, eggshell catch, and a decontaminated plastic nose cone. The sample was then removed from the plastic liner of the corer and placed into aluminum pie pans for compositing before transferred to the appropriate sample containers.
